QUINNIPIAC RIVER BASIN  
MERIDEN, CONNECTICUT  
**BRADLEY HUBBARD RESERVOIR DAM**  
**CT 00132**

PHASE I INSPECTION REPORT  
NATIONAL DAM INSPECTION PROGRAM

SEPTEMBER, 1980

4. TITLE (and Subtitle)  Bradley Hubbard Reservoir Dam  NATIONAL PROGRAM FOR INSPECTION OF NON-FEDERAL DAMS		5. TYPE OF REPORT & PERIOD COVERED  INSPECTION REPORT

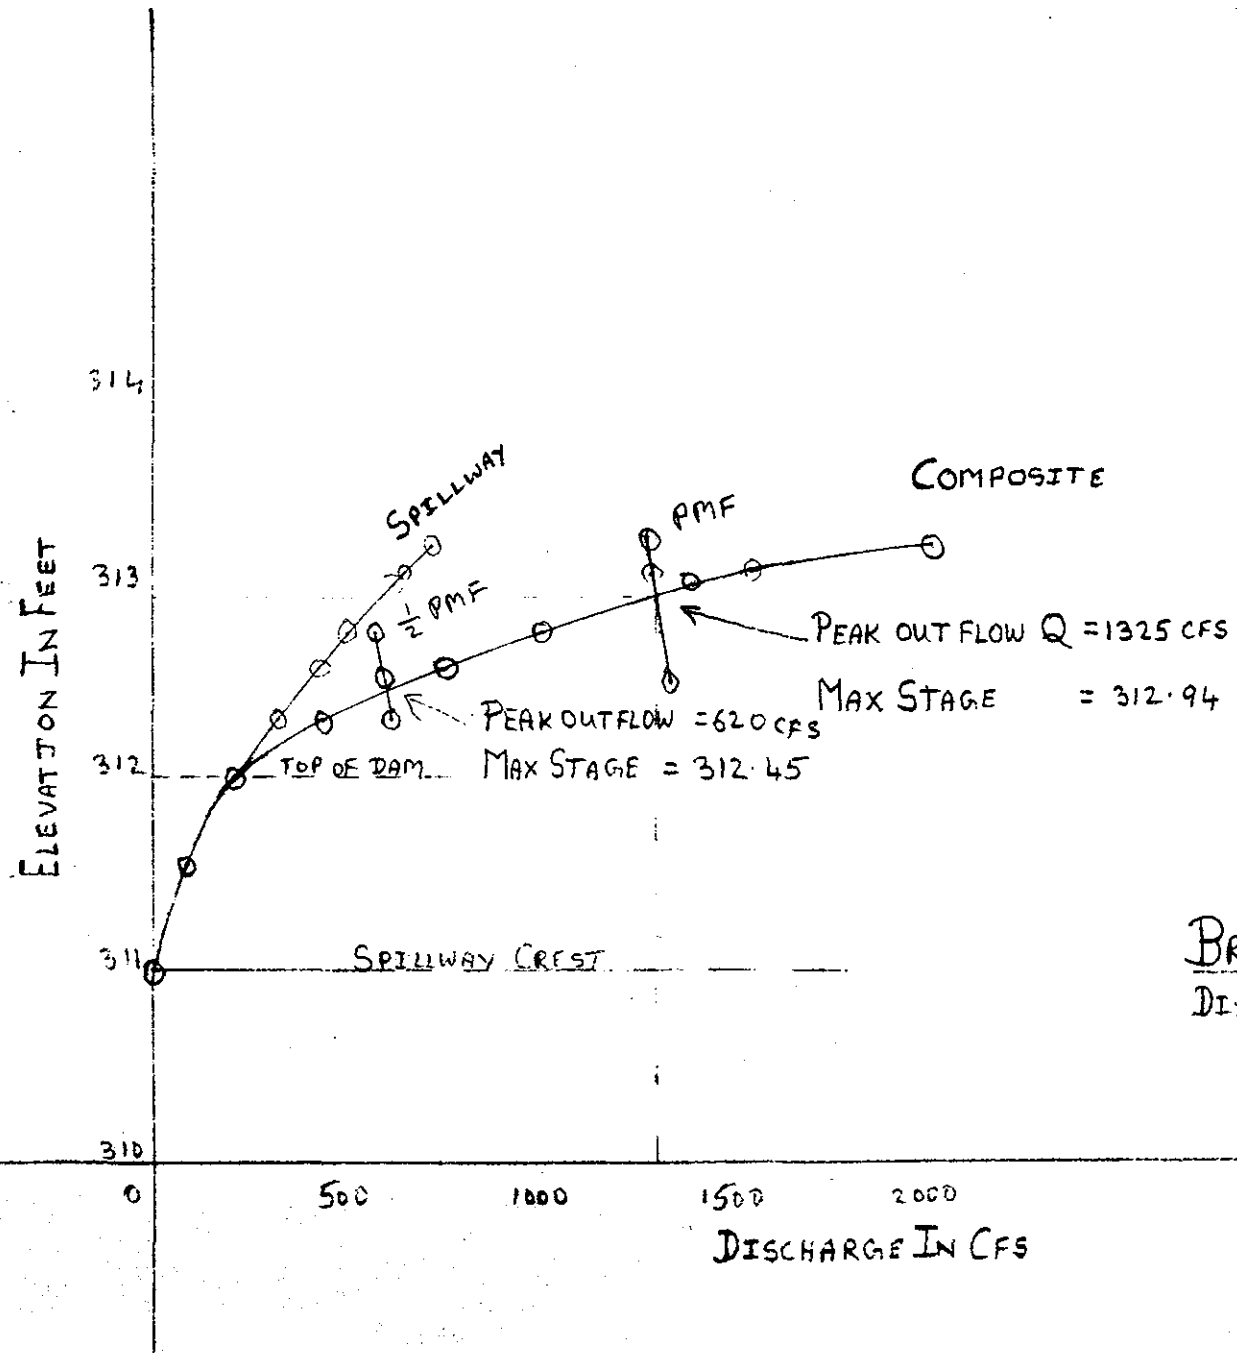
BRADLEY HUBBARD RESERVOIR  
DISCHARGE RATING CURVES

DISCHARGE RATING CURVES FOR TOTAL  $Q$  (COMPOSITE) AND SPILOWAY ARE PLOTTED ON SHEET 7.
